Town of Jamaica Local Hazard Mitigation Plan

Town Adopted July 13, 2020
FEMA Final Approved July 21, 2020

Prepared for the Town of Jamaica
by the Windham Regional Commission

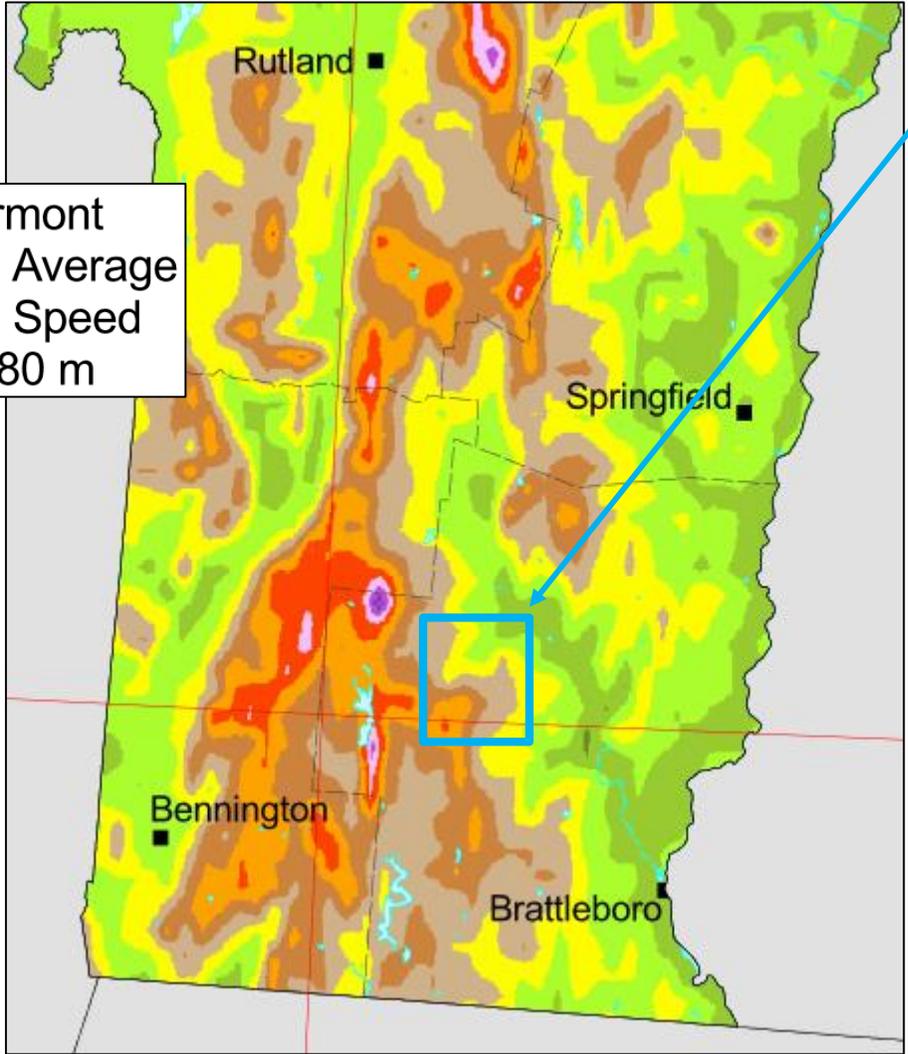
Vermont
Annual Average
Wind Speed
at 80 m

This map from Energy.gov shows the Annual Average Wind Speed at 80 Meters. The highlighted square roughly encompasses the Town of Jamaica.

High wind events are not localized and can affect any part of the Town. Higher elevations are more susceptible. Jamaica has a mountainous rough topography, along with valleys where much of the settlement is located. Average wind speeds correspond with the highest elevations, though Plan participants noted that strong gusts do sweep through the valleys, as well. The map on the following page shows annual average wind speeds for southern Vermont south of Rutland. This gives an idea of wind speed in the town in comparison to its surroundings. The purple area to the west of the highlighted square is Stratton Mountain, which gets particularly high winds and can serve as a point of reference or comparison to the highlighted square indicating Jamaica.

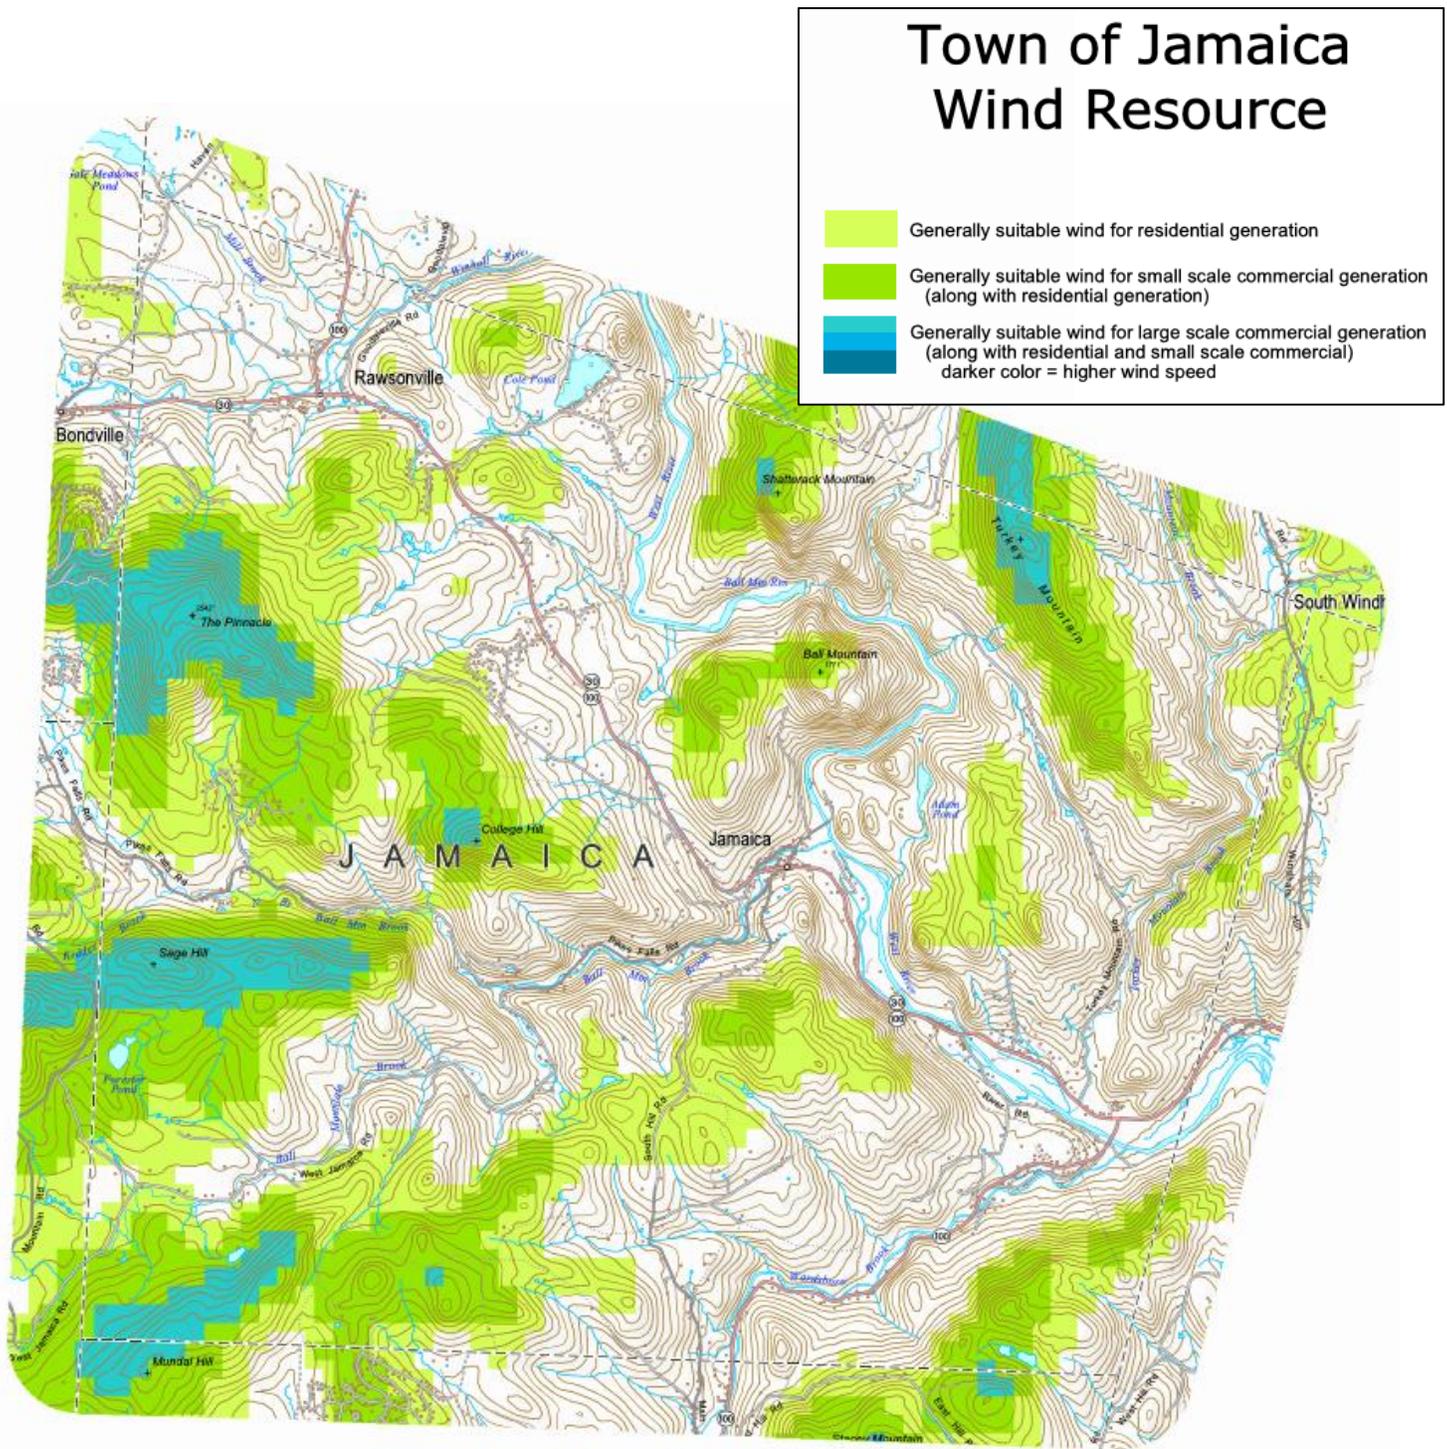
For a more localized look at wind speed, the below map shows wind power opportunity correlated only to wind speed⁷. The highest points in town, areas such as the Pinnacle, Sage Hill, Mundal Hill, and Turkey Mountain have the highest wind speeds in the Town.

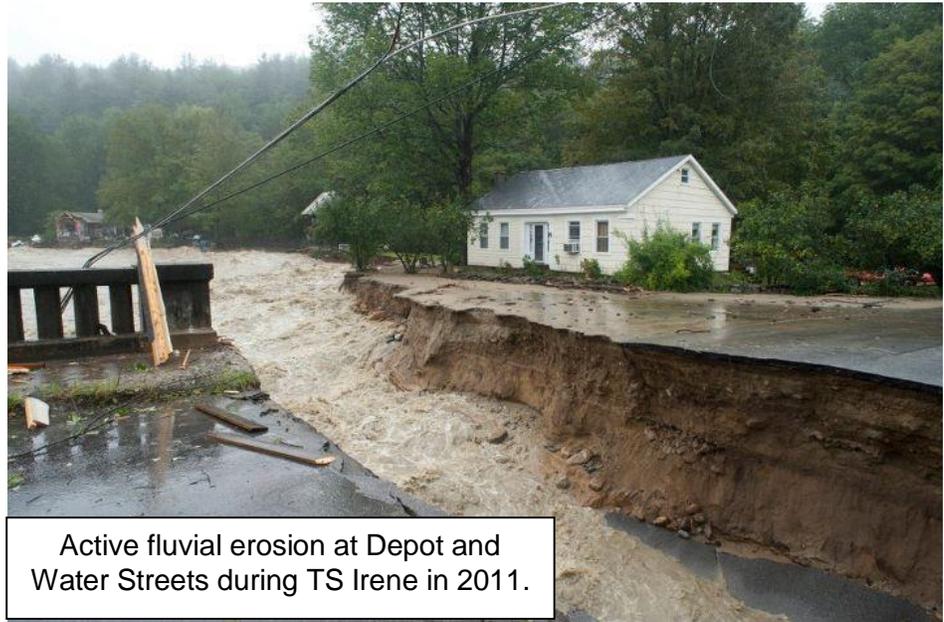
Active fluvial erosion at Depot and Water Streets during TS Irene in 2011.

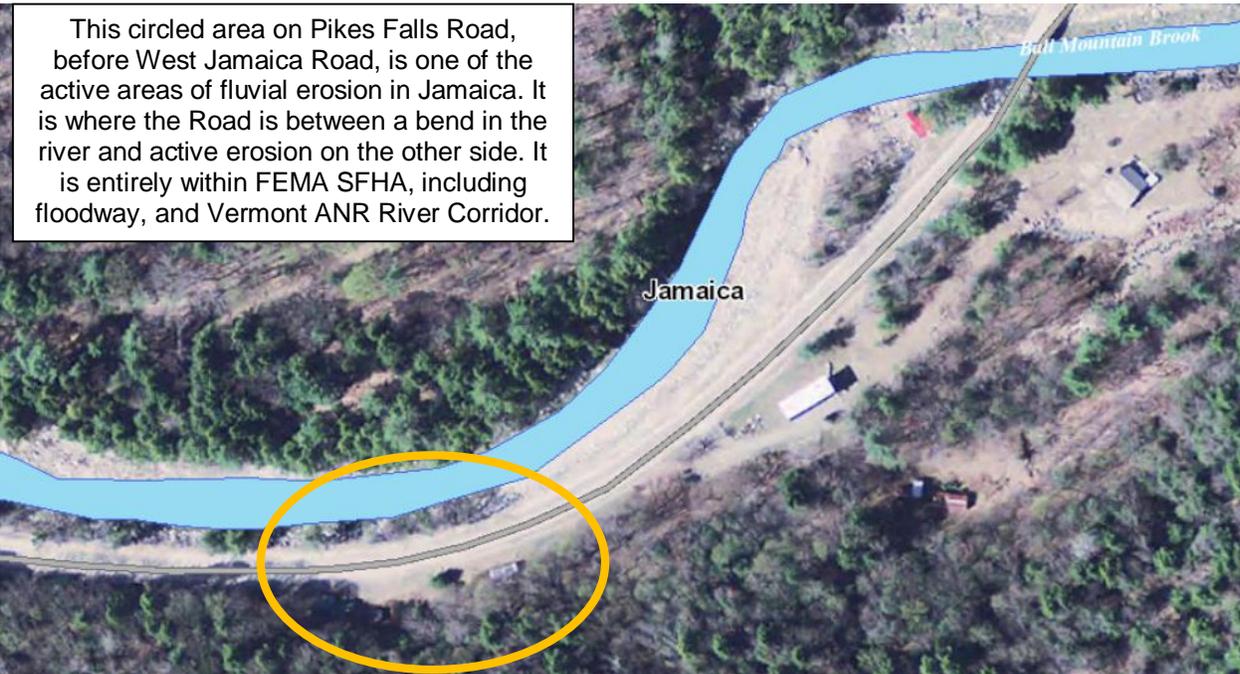
Pictured above is Pike's Falls Road and the adjacent Ball Mountain Brook. Note the proximity of the road to the waterway, especially close to some of the meander bends. These bends in the river are prone to movement as part of natural river processes, and their movements can be even more dramatic when manmade impacts and development upstream impinges on these natural stabilizing forces. The interaction of the natural and unnaturally dramatic forces of river movement, combined with the stationary location of the closely located roads is what leads to road damages during heavy weather events.

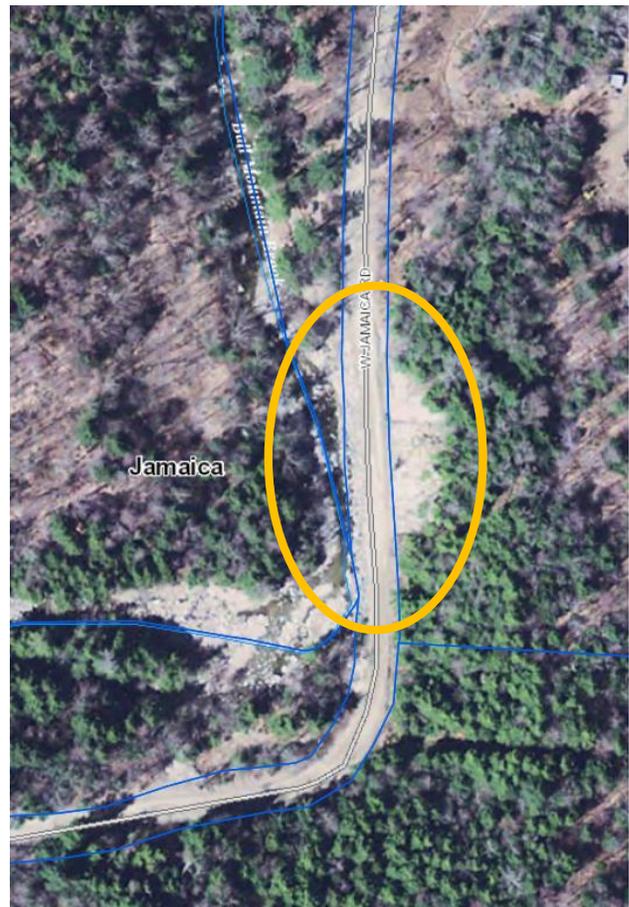
Pictured to the right is the largest area of fluvial erosion in Jamaica, and it is on West Jamaica Road. This Road in this area was completely taken out by fluvial erosion and a slope failure, which is visible on the aerial image. As in the instance on Pike's Falls Road, the meander bend in the River was exaggerated with the increased flows during TS Irene and overtook the Road, which lies within the River's natural River Corridor. Photos on the next page show during the damages and after the Road was repaired. These instances are continual concerns with

large rain events and storms. The slide remains a continual issue and mud comes down incrementally after rain events. There was consideration of a retaining wall but the cost of the wall would be \$250,000 and the cost was considered not necessary. The top of the slide is 90' out of the road right of way. This is the largest area of concern in Jamaica, according to the Road Foreman. He does not think that the severity of damage experienced during Irene will occur again. Because of the mitigation work that was completed after TS Irene, the Road Foreman feels that is not probable that there will be another erosion event of the scale of TS Irene in this location, but this will continue to be a maintenance issue for the Road Crew. The slide is on private land so the town is limited with what they can do.

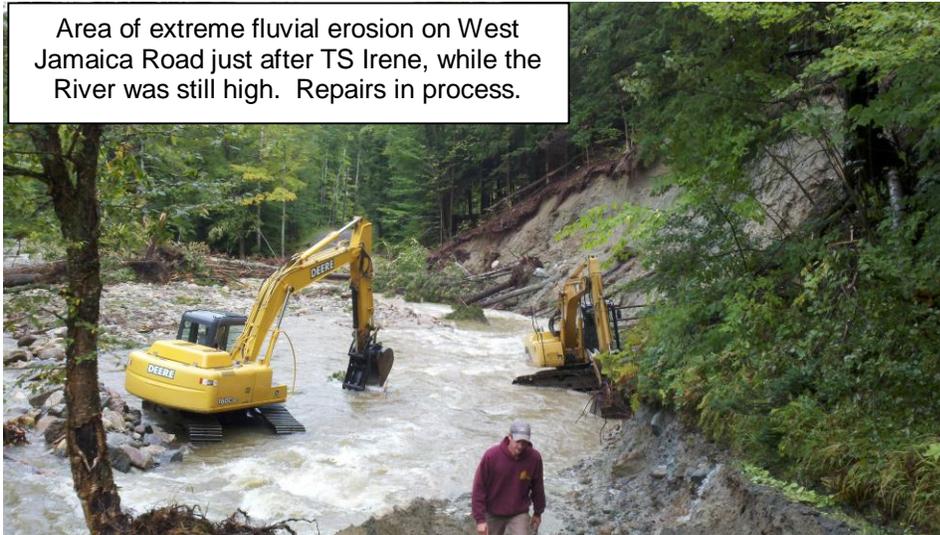
Area of extreme fluvial erosion on West Jamaica Road just after TS Irene, while the River was still high. Repairs in process.

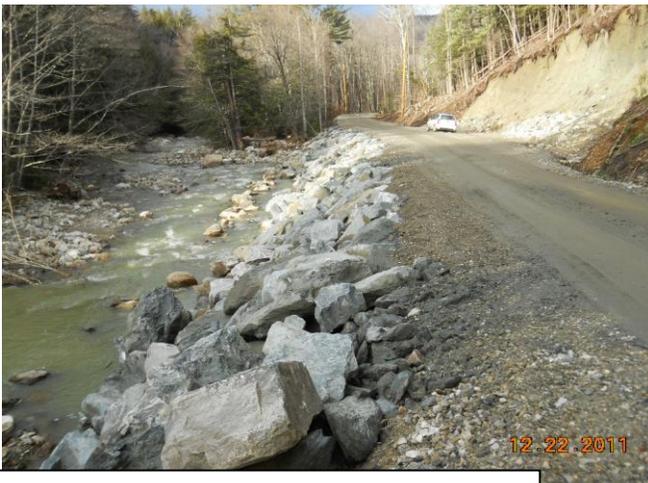
West Jamaica Road after repairs following TS Irene. Note the proximity of River and Road.

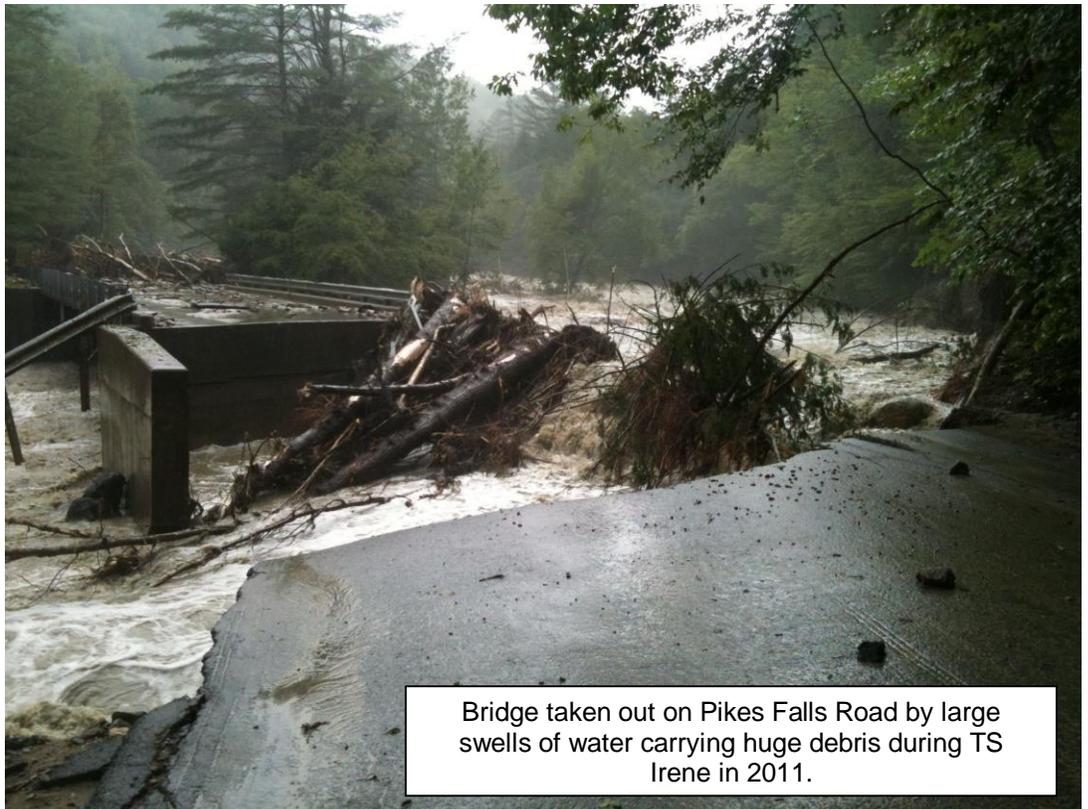
Bridge taken out on Pikes Falls Road by large swells of water carrying huge debris during TS Irene in 2011.

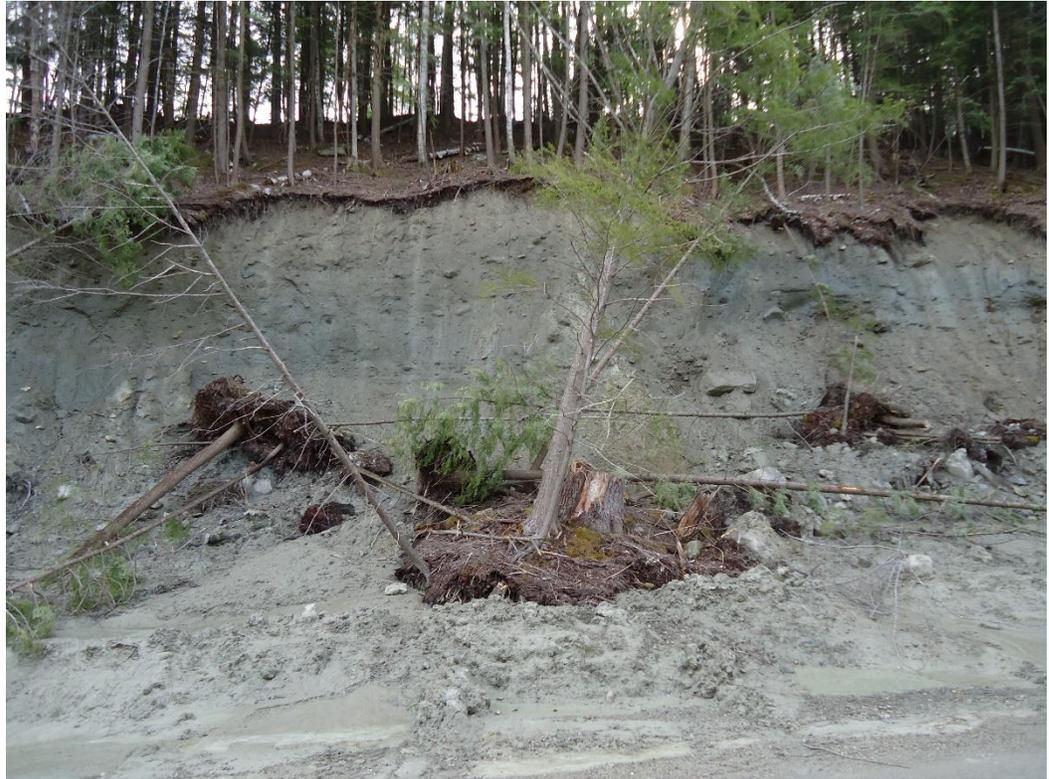
There is an active erosion zone that is 250' long and 100'+ tall in the River Corridor of the stream along West Jamaica Road, with trees falling.

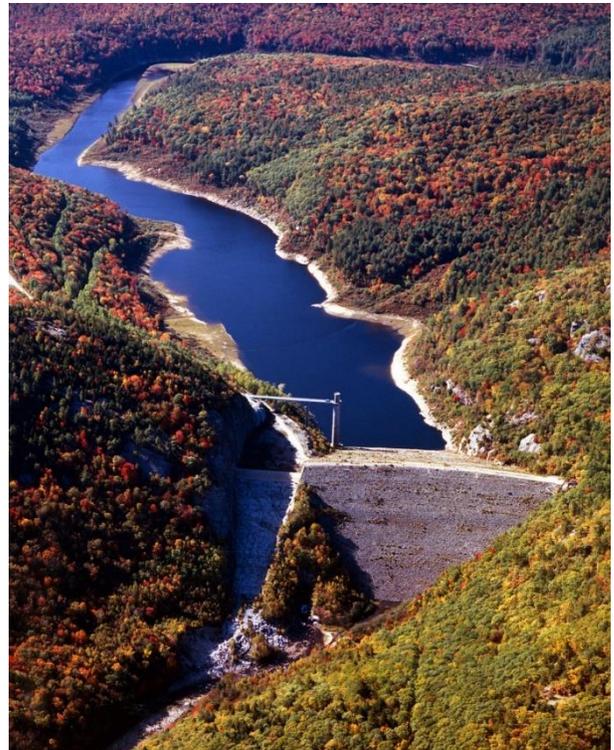
The USACE has determined that Ball Mountain Dam is structurally unsound due to internal erosion damage causing seep holes through the dam. The Town has been briefed by the Army Corps about different failure scenarios, including both incremental and catastrophic failure. The EMD considered putting sirens up to alert the population, but the timeframe that would be

Sediment accumulation in the pool behind Ball Mountain Dam poses a continuing serious risk to water quality and aquatic and riparian habitat in the West River both upstream and downstream of the dam. Ball Mountain Dam was not designed to impound a permanent pool, but a pool has been maintained behind the dam since shortly after it was constructed in 1960. Several hundred thousand cubic yards of sediment have accumulated in and near the historic river channel underneath the surface of the pool. In the mid 1990's two successive accidental sediment releases from the dam caused severe damage to aquatic and riparian habitat along the West River. Major fish kills resulted from both of these releases, and ecological and economic losses were significant²¹. Future accidental sediment releases are possible because the accumulated sediment in the pool cannot be prevented from being swept through the gate works if automated pool-depth regulation mechanisms fail due to improper maintenance, component failure or human error.

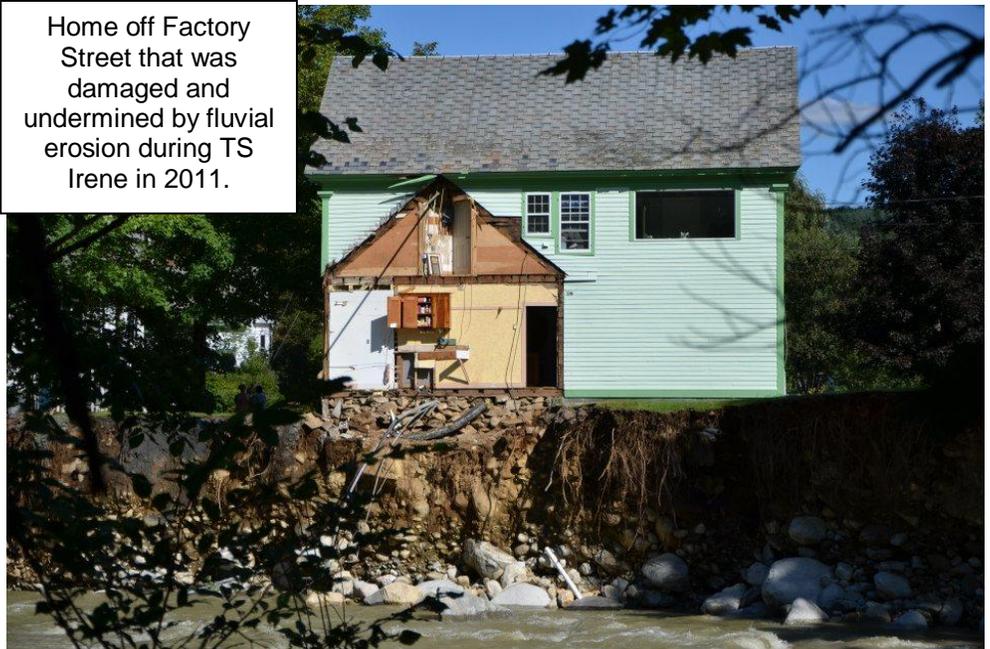
Home off Factory Street that was damaged and undermined by fluvial erosion during TS Irene in 2011.

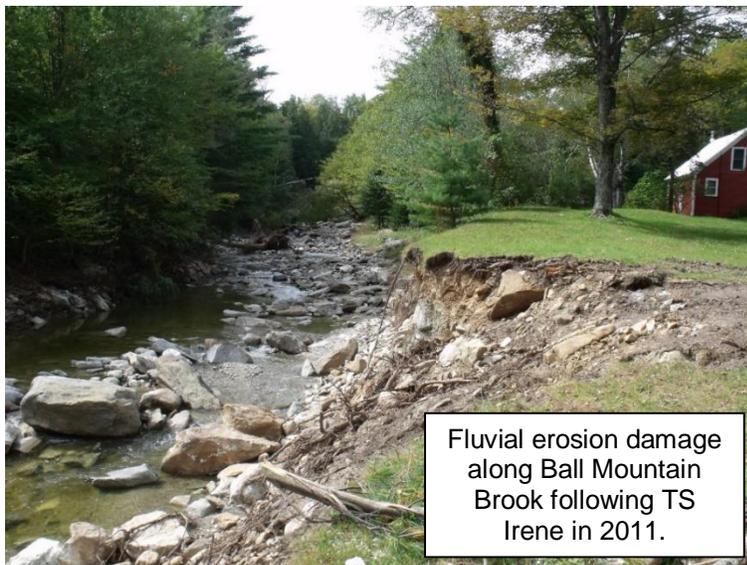
Fluvial erosion damage along Ball Mountain Brook following TS Irene in 2011.
