Town of Marlboro Local Hazard Mitigation Plan

Adopted October 27, 2016
FEMA Final Approved November 29, 2016

Prepared for the Town of Marlboro
By the
Windham Regional Commission

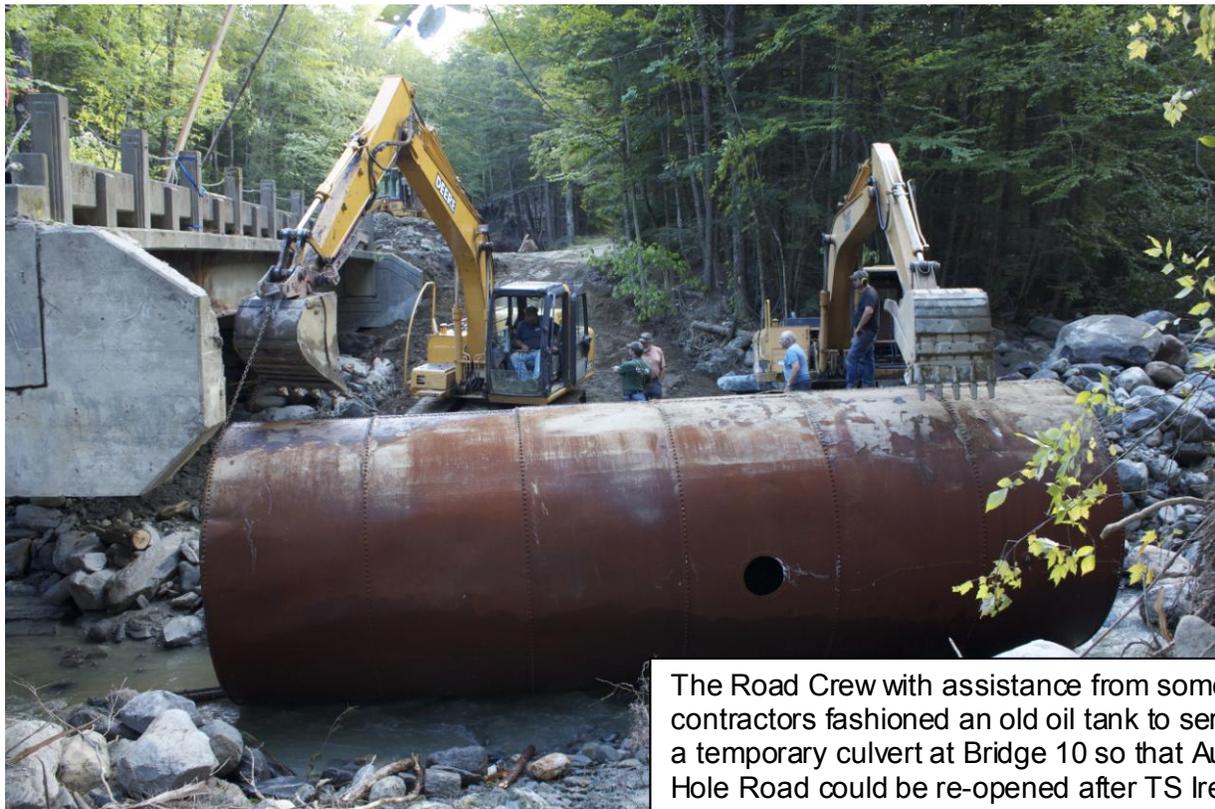
The Road Crew with assistance from some local contractors fashioned an old oil tank to serve as a temporary culvert at Bridge 10 so that Augur Hole Road could be re-opened after TS Irene in 2011. Local ingenuity and a can-do attitude helped Marlboro recover after the devastation. Photo courtesy of Forrest Holzapfel

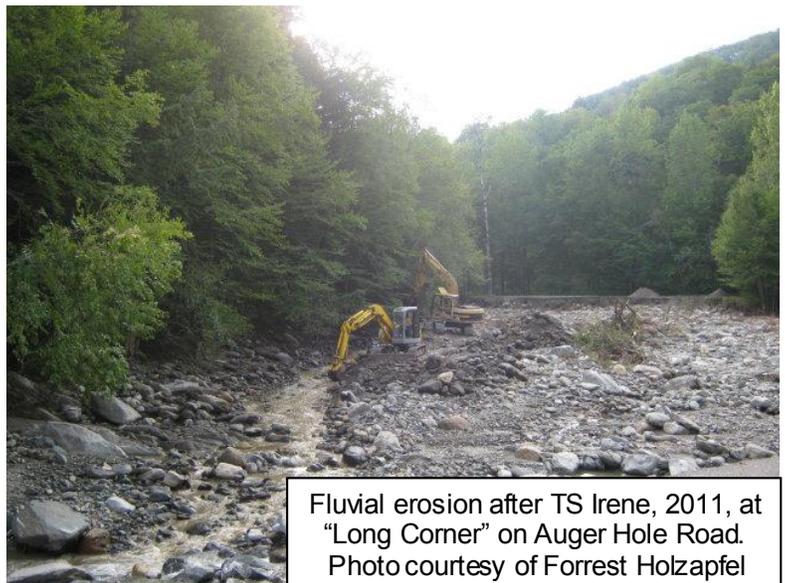
Fluvial erosion after TS Irene, 2011, at "Long Corner" on Auger Hole Road. Photo courtesy of Forrest Holzapfel

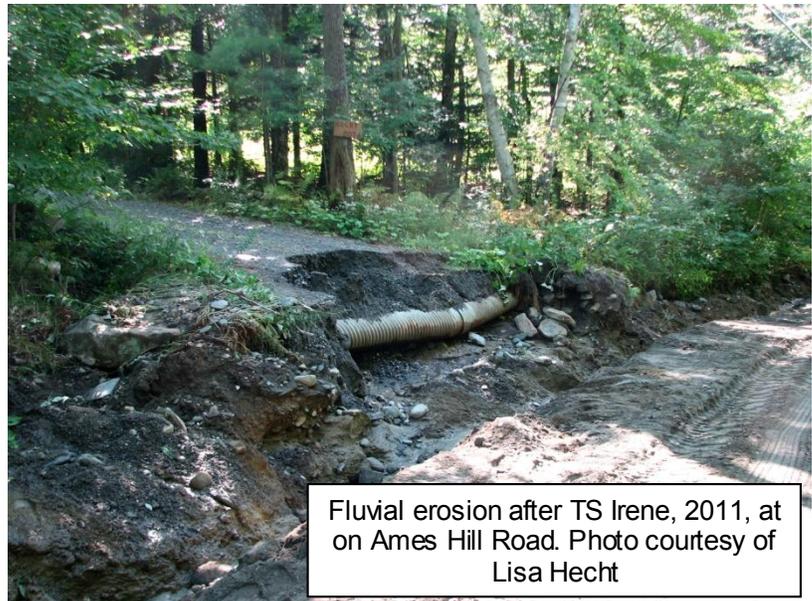
Fluvial erosion after TS Irene, 2011, at on Ames Hill Road. Photo courtesy of Lisa Hecht

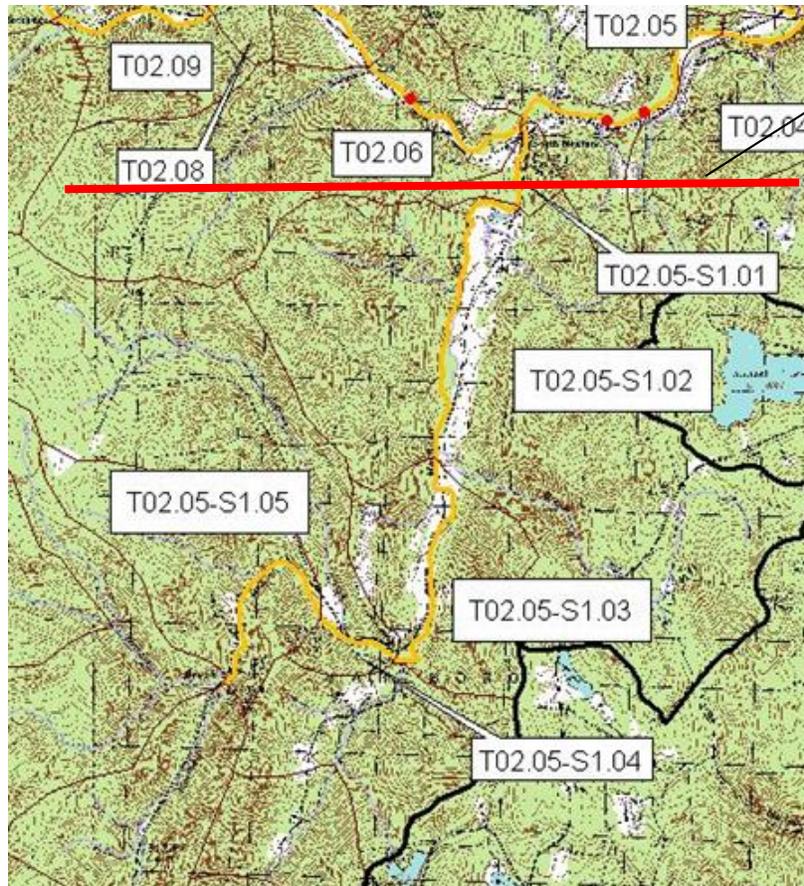
This is roughly the Marlboro/Newfane town line. Four segments of the Marlboro Branch of the Rock River lie south of this line. They include: T02.05-S1.02, T02.05-S1.03, T02.05-S1.04, and T02.05-S1.05.

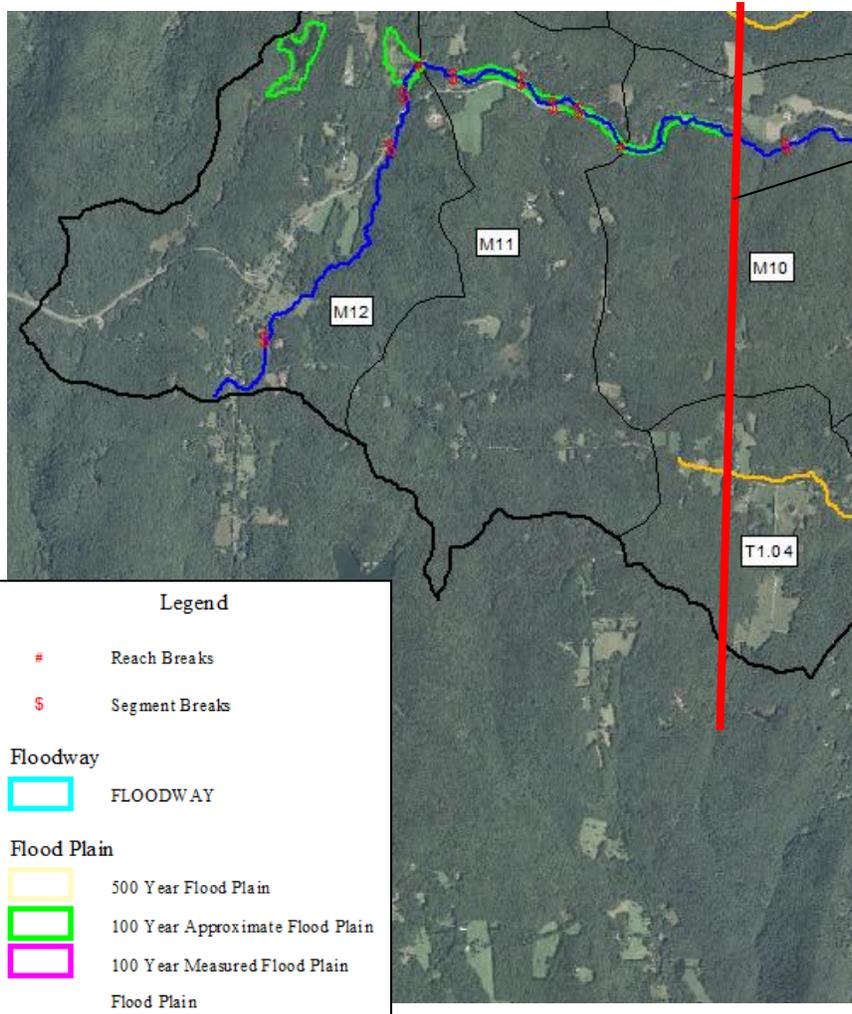
The red line is approximately the Marlboro/ Brattleboro town line, with Marlboro to the west. Stream segments in Marlboro include: M10, M11 and M12. The channel between M12 and M10 has a 4.1% channel slope.

M10 – There is significant erosion on both banks: 29% on the left bank and 24% on the right bank. Route 9 causes a change in the valley width, though this segment is very broad. There is one undersized bridge at the downstream end that is both a floodplain and channel constriction with deposition above and below. There are multiple gravel bars and seven flood chutes and an old mill dam site with extensive beming and channelization toward the upstream end of the segment. The upstream segment has multiple flood chutes, steep riffles, stormwater inputs, four mass failures, and significant encroachment from Rt 9.

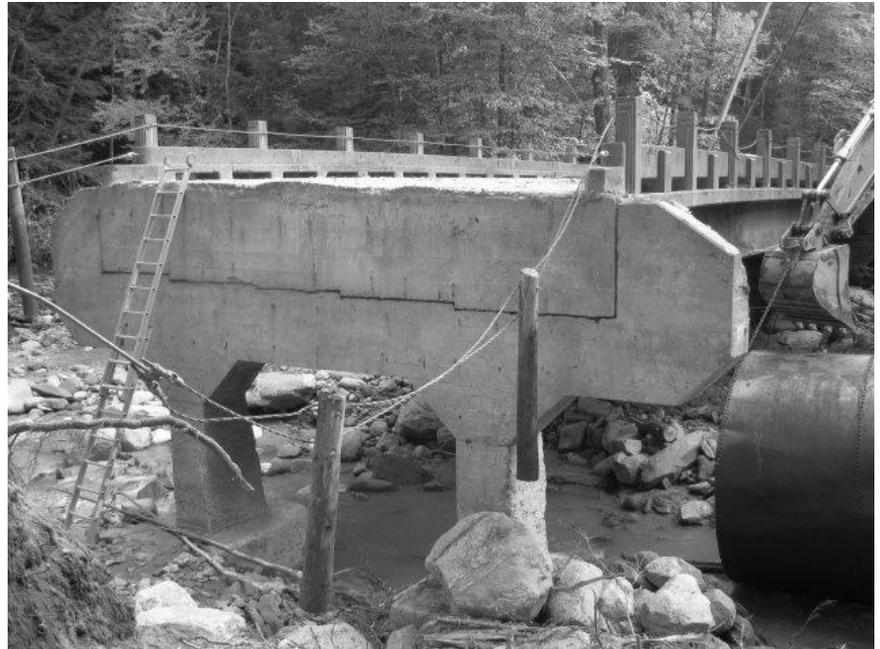
Bridge 10 is pictured below after TS Irene in 2011. Residents were using the ladder in the photo to get across the bridge. Photo courtesy of Forrest Holzapfel

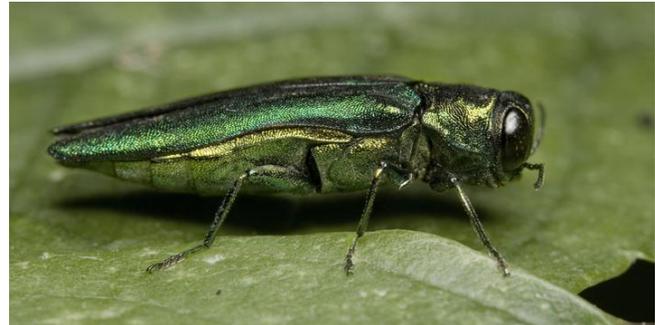
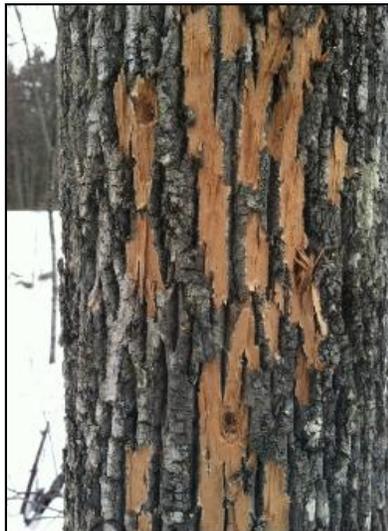
Blonding with pecked holes on ash trees is a sign of EAB infestation.

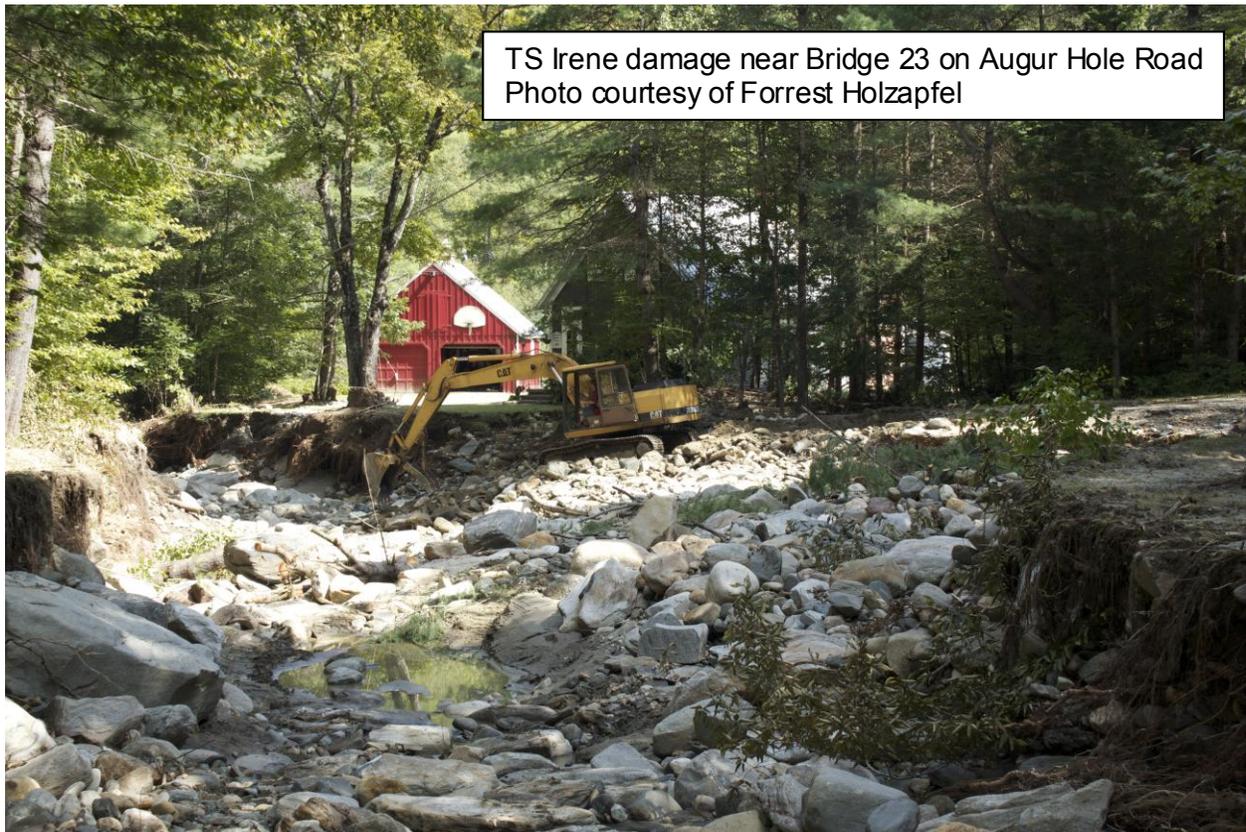
TS Irene damage near Bridge 23 on Augur Hole Road
Photo courtesy of Forrest Holzapfel

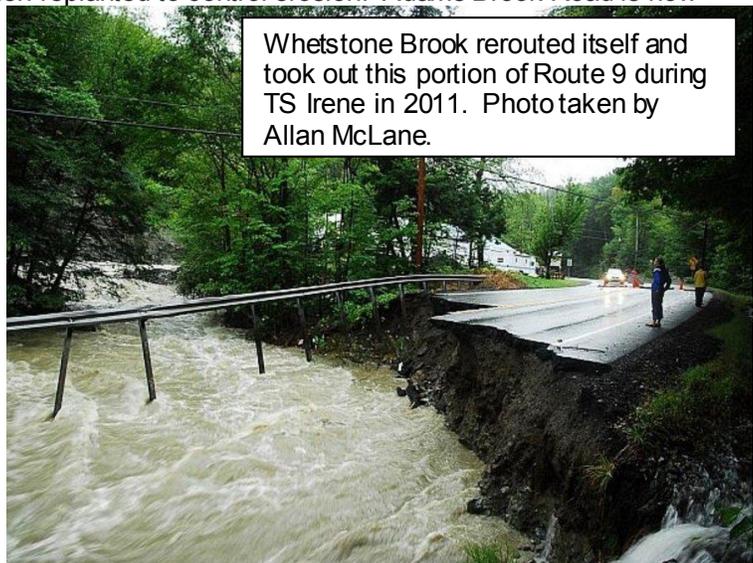
2. The bridge immediately east of where McArthur Road meets Route 9 was completely washed out by TS Irene in 2011 (pictured to the right). The bridge was then upgraded with a larger concrete arch precast bridge upon replacement. VTrans did this upgrade, as the bridge is on a State road.

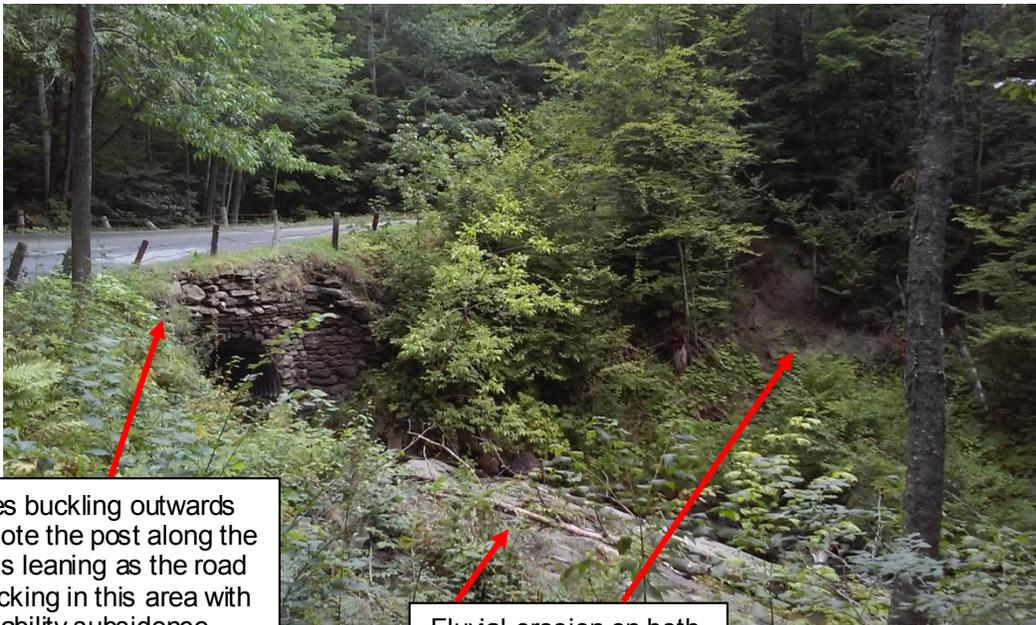
Problem: The structure size is inadequate and it narrows the flow channel which in turn is causing downstream fluvial erosion and bank failure. A large event could cause a debris jam to plug the culvert and the water to overtop the road. Not addressing the issue will enlarge the downstream fluvial erosion and threaten the south bend of the road. In addition, the culvert is overlain with rocks which form the structure that the road is on. This is a steep curved road and the inner curve of the road is already sinking and the road is starting to fail. The rocks forming the structure are buckling outward on the

downstream side and it is predicted the structure/road will fail within three years without action. If this were to happen, the road would collapse into the stream. This is a major travel corridor in the area with around 450 cars traveling it per day. There is no easy short-cut

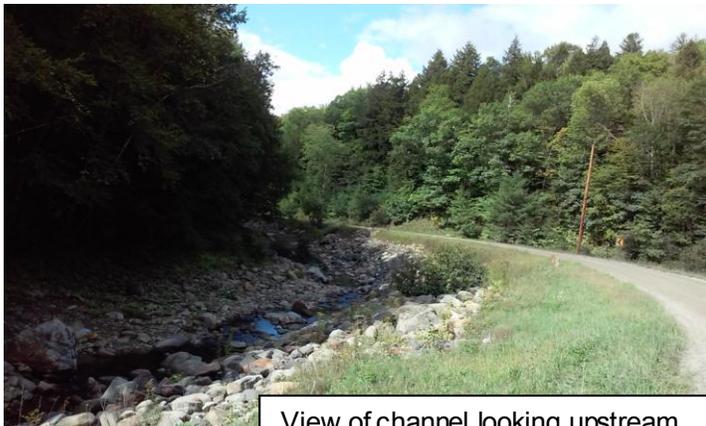
View of channel looking upstream

Solution: Removing this berm will allow floodwaters to access the old channel and more floodplain area and thus dissipate floodwaters, because floodwater will have a larger area to cover. Material removed could be used by the road crew for fill.

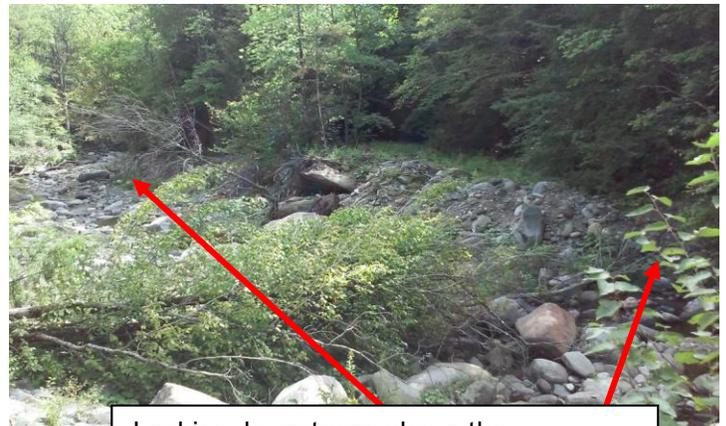
Looking downstream shows the approximate extent of berm to be removed

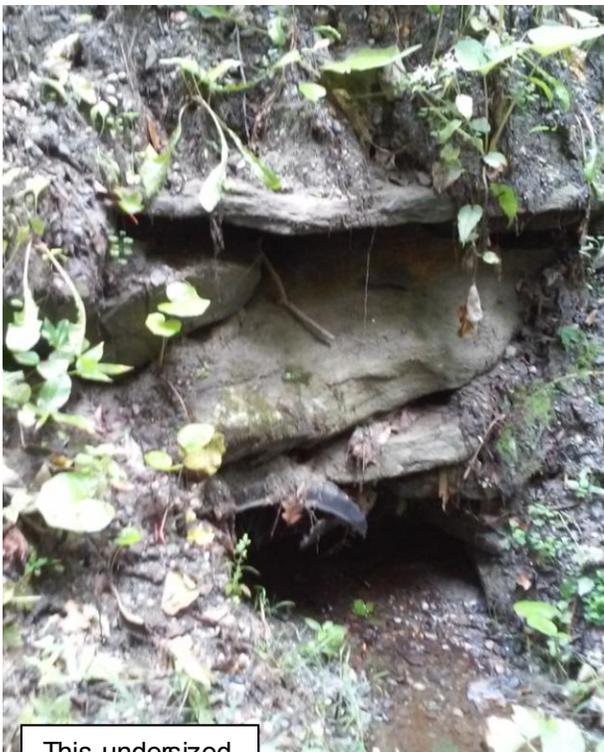
This undersized 2' culvert is also collapsing.

Solution: Install rip rap along the embankment alongside the road to protect the road and upsize the culvert from 2' to 6' to support larger events at bankfull width to prevent road from overtopping during large events. This is a highly travelled road.

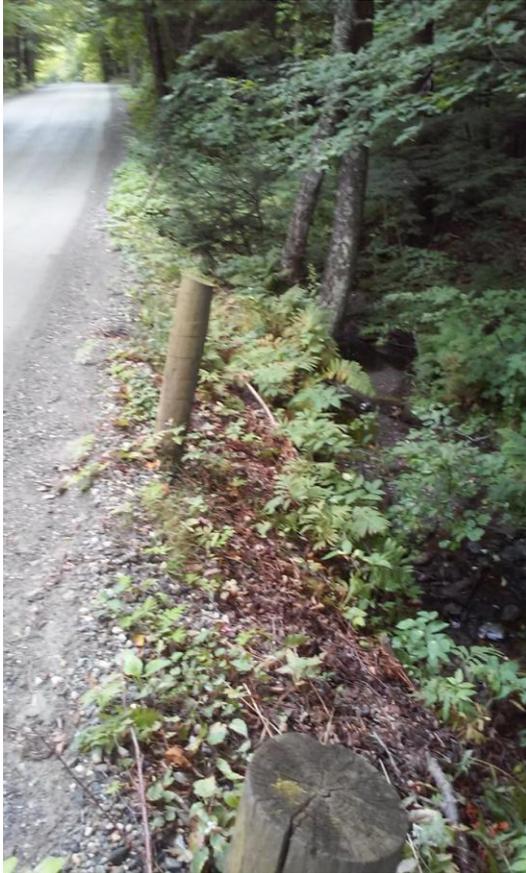
Roadside upstream of Culvert 18: Stream alongside Higley Hill Road is eating away the road embankment. The leaning trees and post are evidence of this fluvial erosion. Part of the problem is also stormwater flowing off of the road surface.

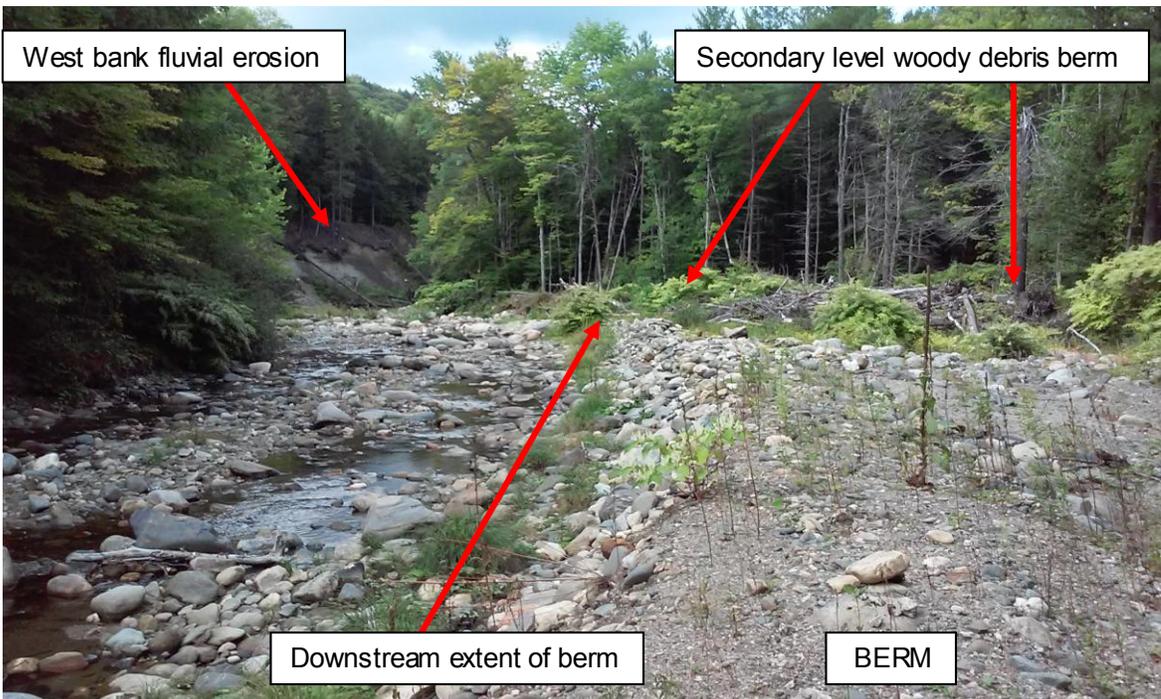
Berm removal along the Marlboro Branch of the Rock River at the northern end of Auger Hole Road

Problem: Two levels of berms have formed because of TS Irene debris and rock material. The berm closest to the waterway is about 700 cubic yards of material. This blocks floodwaters from accessing much floodplain area which, if they could access,

The second level of berm, farther away from the waterway, is much closer to the forested area and consists mainly of woody debris. The closer berm is mainly fill and rock material. It was determined by VT ANR that the second berm can remain while still allowing the benefits discussed by removing the first and closer berm to the waterway.

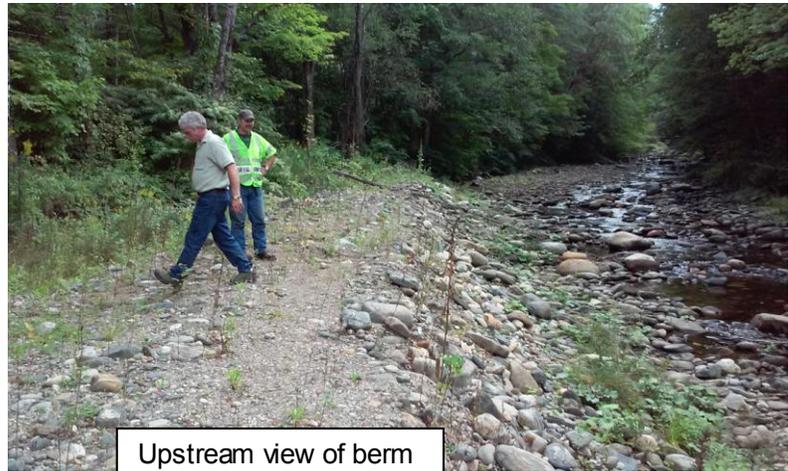
Upstream view of berm

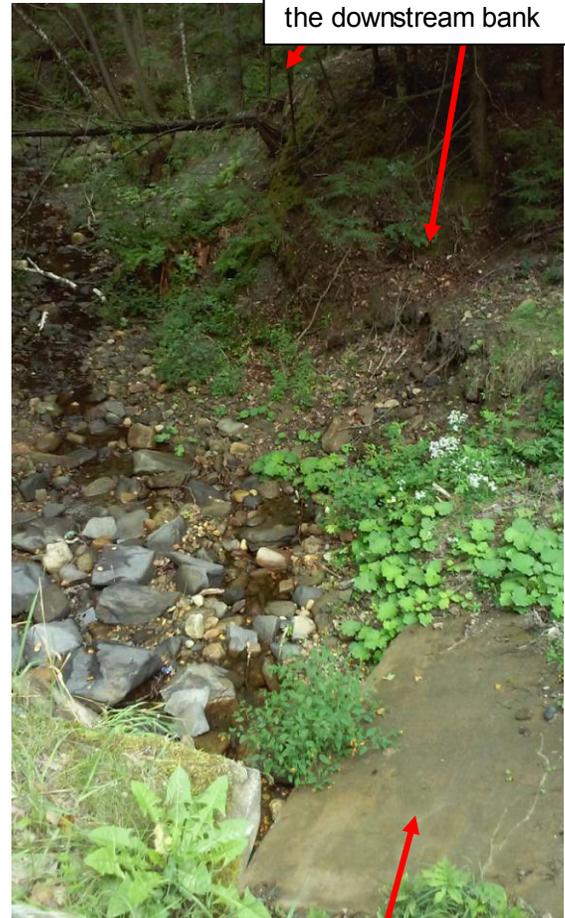
View from standing on the culvert shows the collapsed wing wall

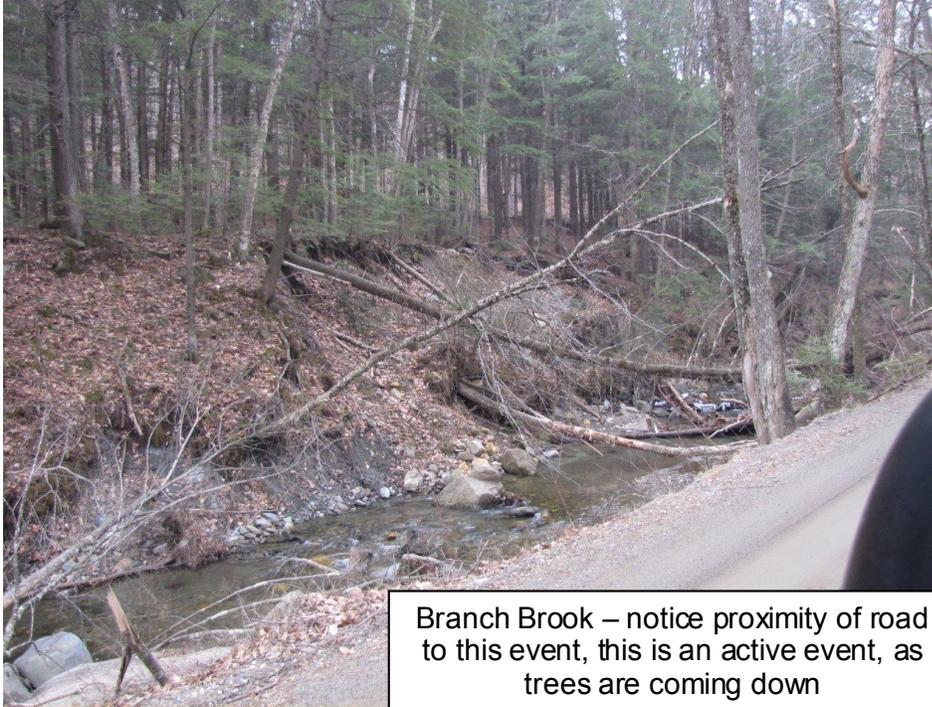
Branch Brook – notice proximity of road to this event, this is an active event, as trees are coming down
